# MARINA DI LOANO SHIPYARD FACILITY

Marcello Conti<sup>1</sup> Ing. Carlo<sup>1</sup>

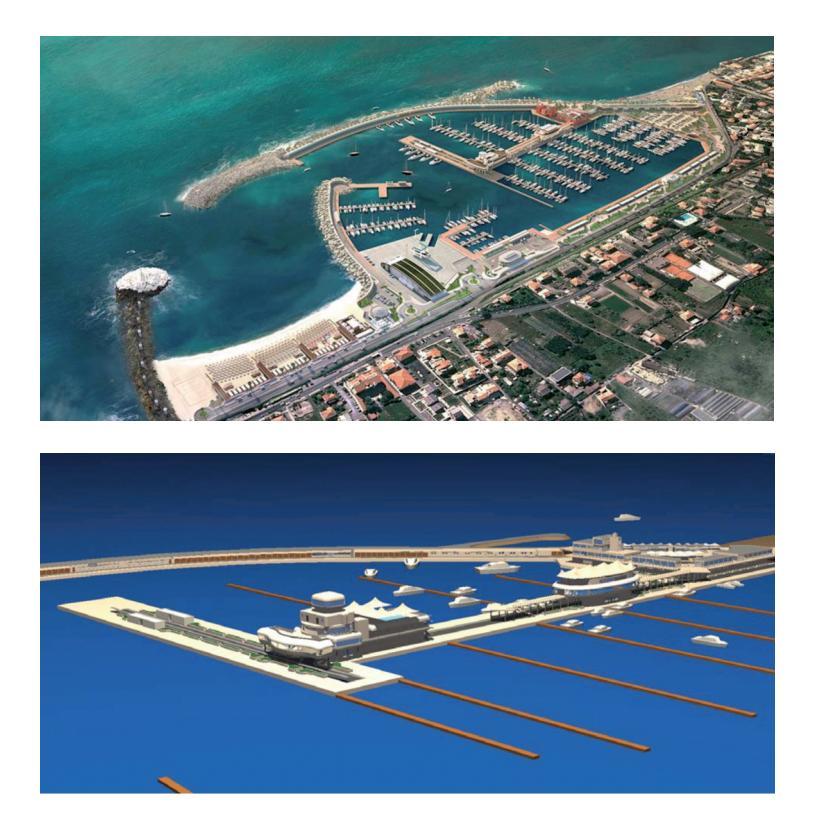
With water depths between 3.50 and 5m m.s.l. Marina di Loano can host boats from 8m to 40m, along its inner docks and floating docks. It provides 827 permanent berths for pleasure crafts and 100 transit berths, as well as a 100 berths rented at rates agreed with Loano Town Council; 3 berths for Coastquard boats; approx. 30 berths for professional fishing boats for a total of more than 1,000 berths.

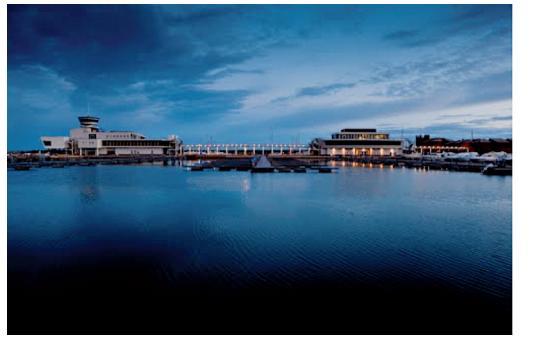
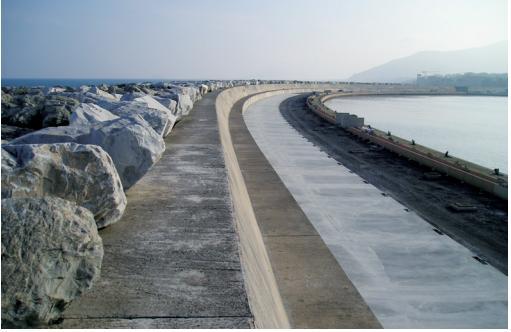
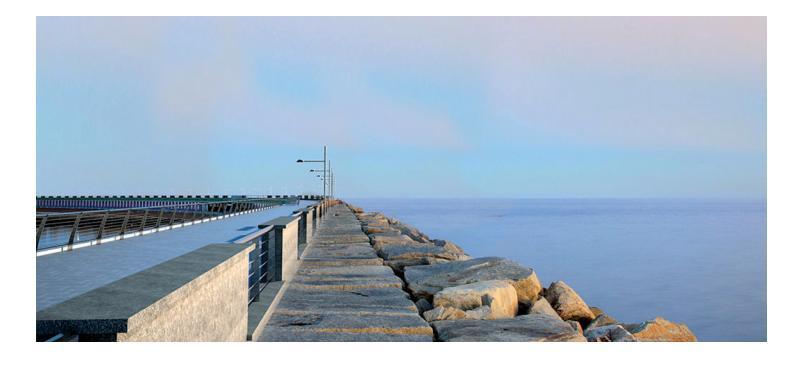
place even in the most severe weather and sea conditions. The outer layer of its main ballast is made up of granite rocks weighing up to 12 tons each, while the upper layer is covered in Carrara marble blocks. On the top of the breakwater wall, over 5m above

sea level, lies the 800m long Seafront Promenade, a prolongation of the town's promenade leading to the far end of the pier, where a characteristic sundial is found. Inside the wall. About 140 car parking spaces are available, along with bathroom blocks, both for public use and for that of the marina guests. On the inner side of the pier the docks host berths for boats longer than 16m.

This is the most imposing and notable marine work in Marina di Loano. 6m high and lying on 60m-wide foundations, the pier's main function is to make the marina a safe

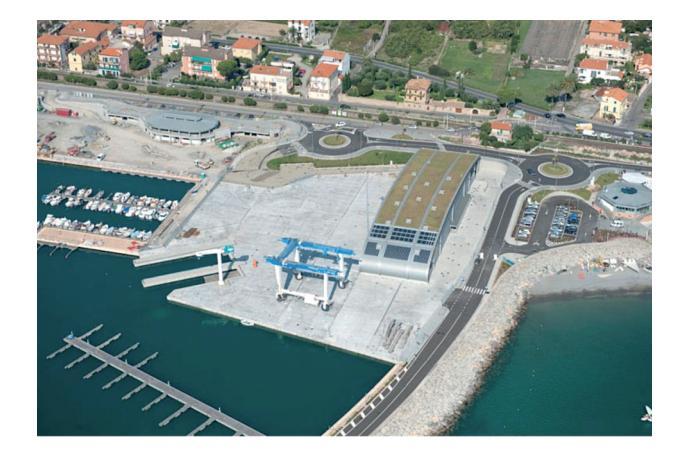
Land reclamation for shipyard and landside facilities has been provided by the dredging of the basin necessary to reach the minimum depth of –3,5m along the landside quay (smaller boats) and–5,0m in other basin areas.

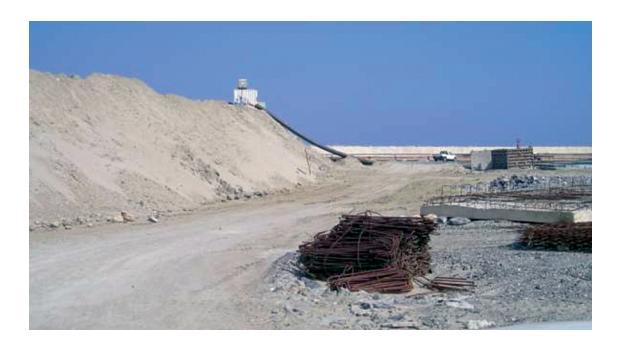
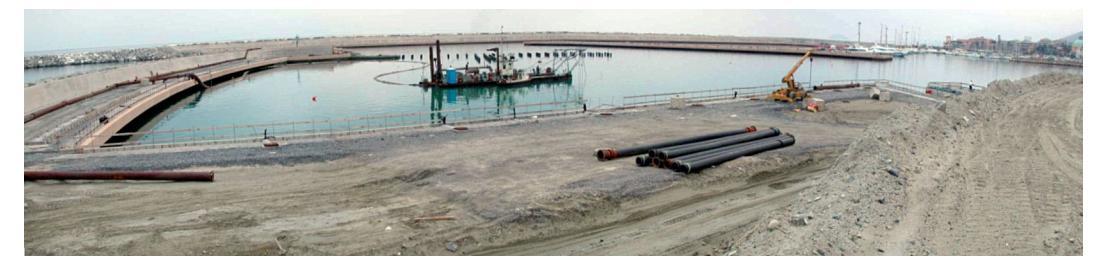
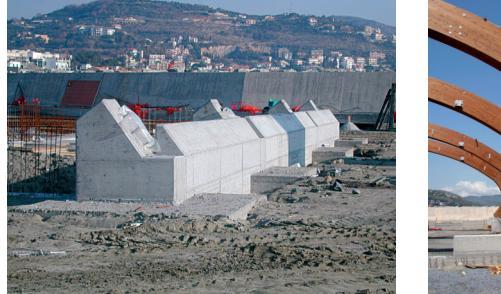
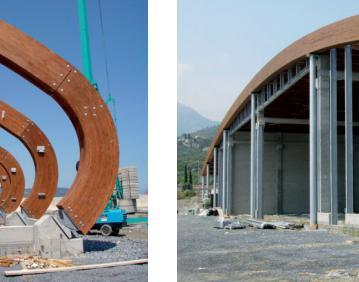
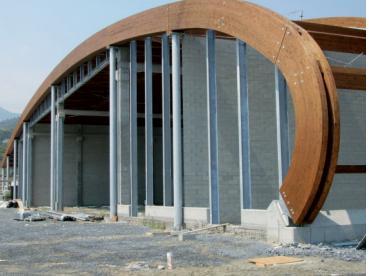
The boatyard facility has been built over an overconsolidated reclaimed land achived using the dredged materials from the basin. The sand heap was up to 12m high above the ground and the material has been furtherly reused for beach filling in Loano public beaches.

The overconsolidation of the ground allowed the use of footings instead of piles with a considerable saving of money.

The laminated glued timber beams have been lifted by crane and assembled in place

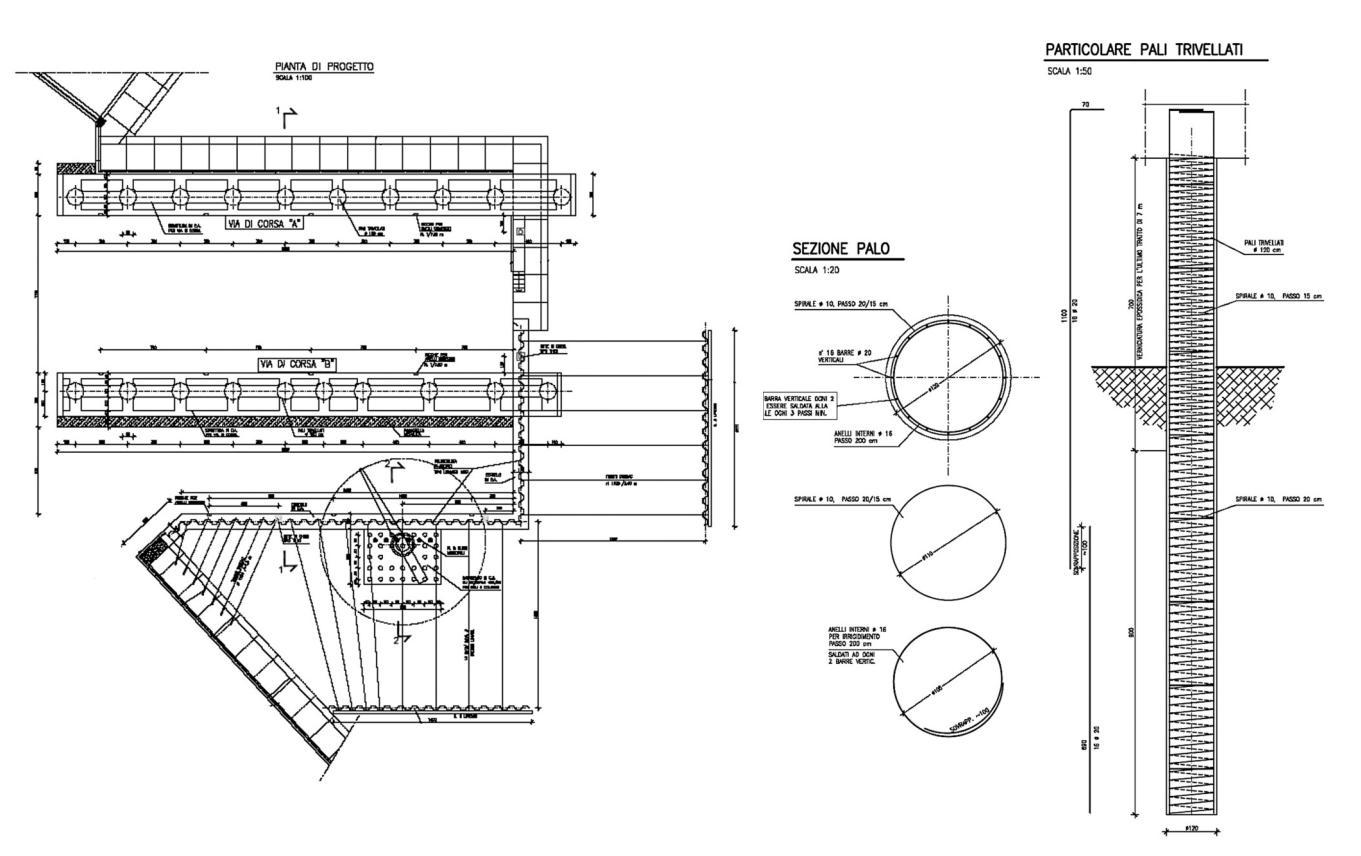
The bigger well has been designed for a 500tons travel-lift. As this was not considered in the original design, a modification of the existing boat wells has been made by removing the original gravity blocks of the quay for a 1200mm steel and concrete piles structure to be placed to support the additional load.

Two towing tanks are also available, measuring 30mx11m and 20mx6.50m.

The smaller tank is 5m deep and has a 40-ton crane.

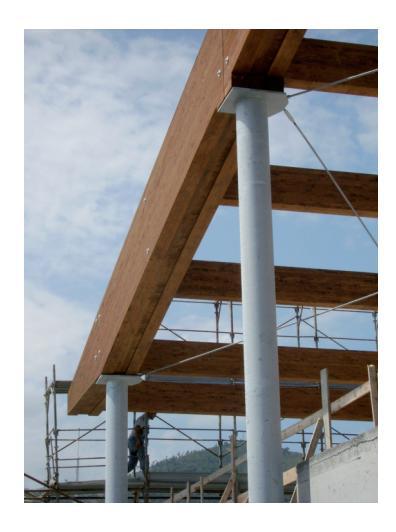
Steel and r.c. columns support big curved glued laminated timber beams, while curtain walls has been designed in sandwich insulated metal panels as well as the roof cover.

Particular attention has been given to the roof. Considering the importance of the impact of such a wide

build surface, different technologies have been adopted both to improve the visual impact and to emphasize the attention to the environment.

Over the roof, by the Harbour side, where orientation and slope are more convenient, solar panel for hot sanitary water production for all the east marina area (boatyard, yacht club and beach services) and photovoltaic panels have been placed.

For the remaining portion of the cover a green roof has been adopted, considering the easiness and safety of access for maintenance.

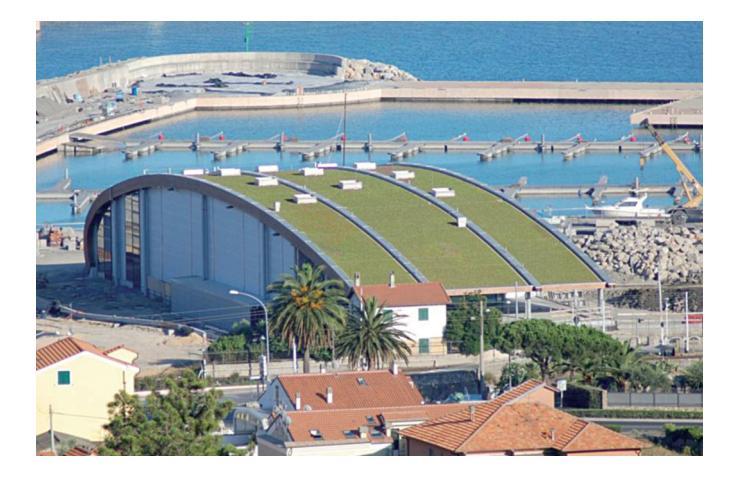
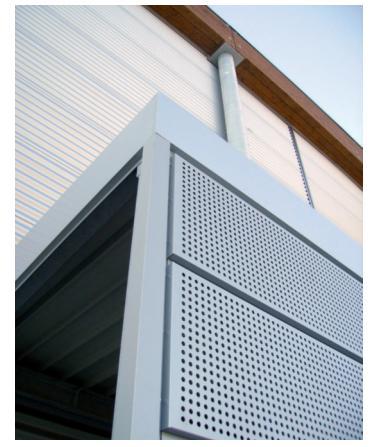
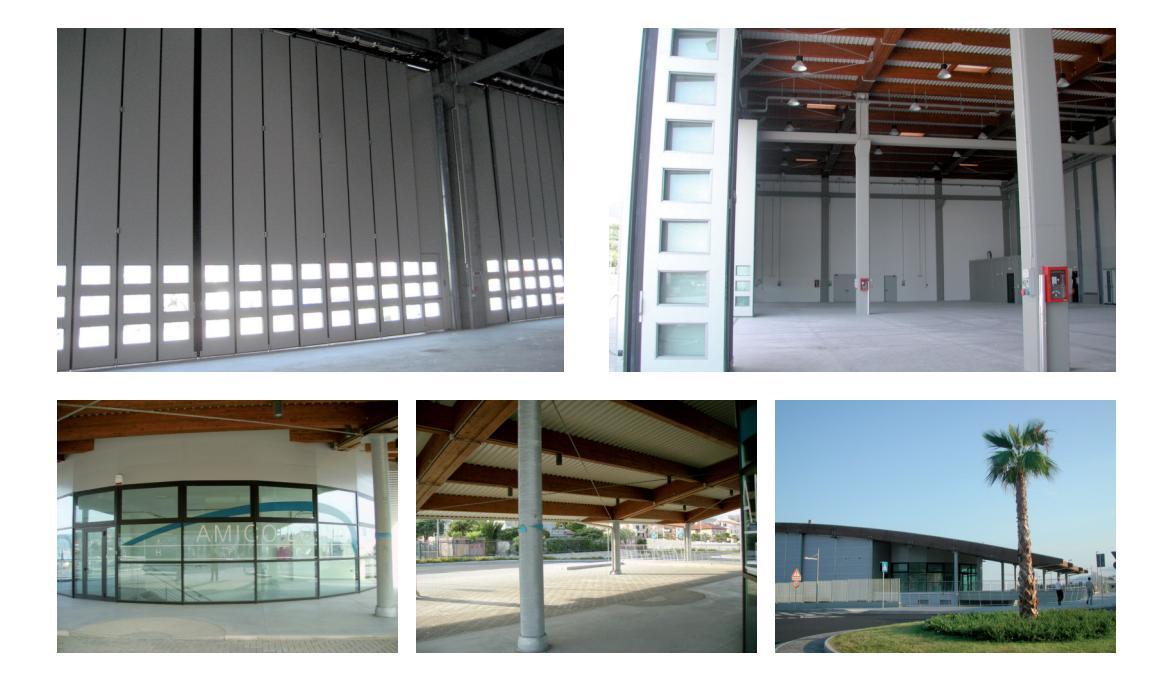
Work on boats up to 70ft can be performed inside the facility thanks to the wide gates and the height of the upper beams giving access to the west side of the building and to mechanical and electrical workshops.

Technical rooms, restrooms and locker rooms for the employees are placed along the east side of the facility. A covered connection space gives protection to the back doors of the shops.

Offices for boatyard management are located in the north side of the building with direct access from the shipyard.

Commercial spaces for nautical wear and equipment are placed at the north side of the facility with access from the promenade under a wide porch. They are organized in two stores connected by stairs and elevator.

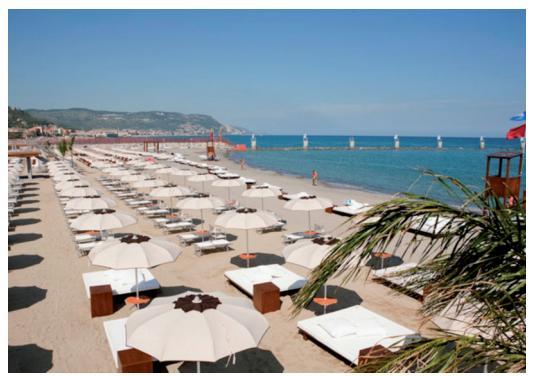
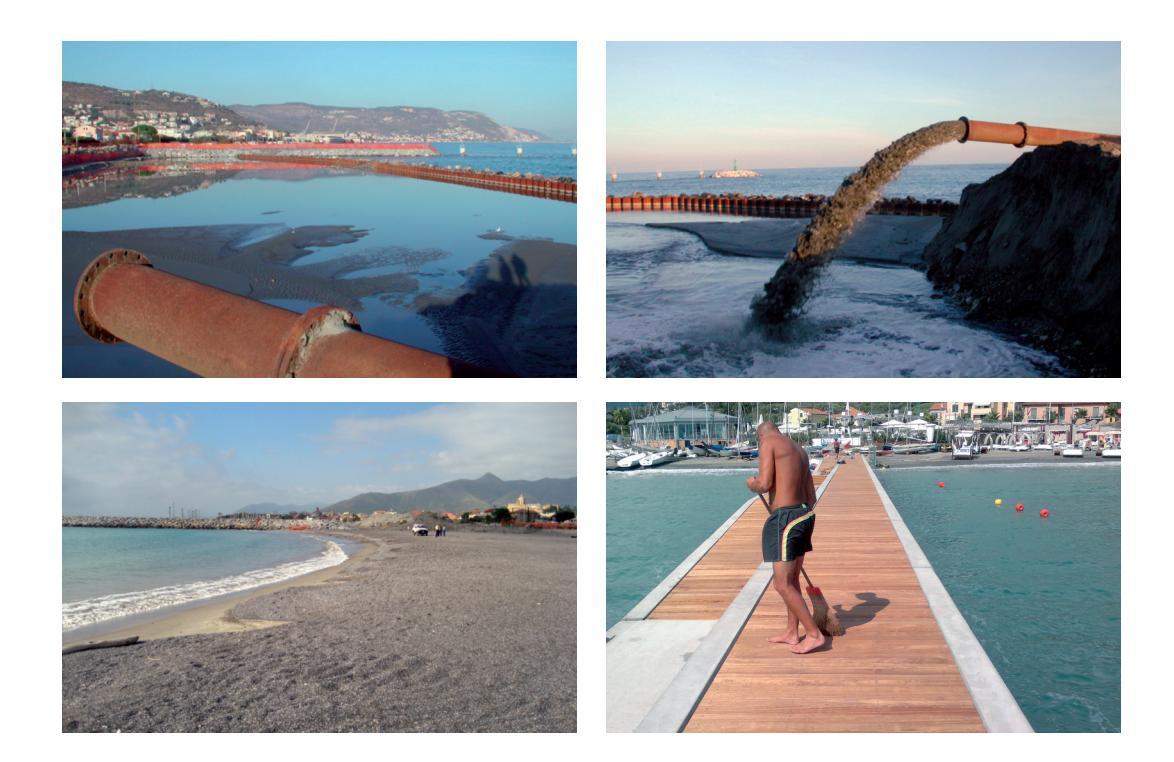
The beach is split into different areas by four jetties that branch out from the Shore Promenade and run perpendicular to the shore. Under the jetties are beach utility rooms, bathrooms and showers. Here nautical tourism lovers, their boats safely moored, will find a cosy corner where they can relax with family and friends. The multifunctional beach is divided into three main areas, sport, sunkeeping and entertainment.

To have the optimal grain size for the surface of the beach, a complex channel system has been prepared to permit the deposition and the separation of silt. A river sand cap has been placed over it and a final layer of fine sand is what you put your feet on.
